AG-AVT-140

Corrosion Fatigue and Environmentally Assisted Cracking in Aging Military Vehicles

Published March 2011

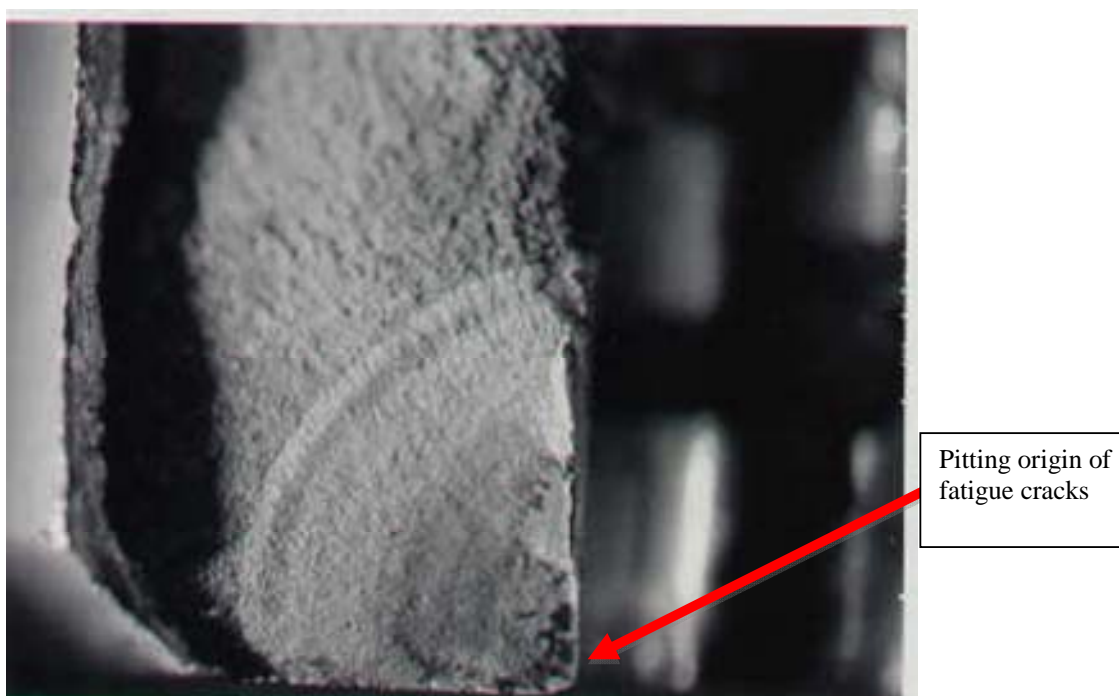
The following is an example of unexpected pitting corrosion on a “non-critical component” detected in service. The C130 aircraft, used in many countries throughout the world, was found to have cracking in a fitting that is in the rear of the aircraft and is referred to as either the “Porkchop” fitting or the “hockey stick fitting”. Which reference is used is a function of the country in which the problem was discovered. Some indicated the problem was due to stress corrosion. This is not viewed likely since the component experiences cyclic loads. When both DND, Canada, and the New Zealand forces were experiencing cracking of the component they decided to have competent failure analysis labs evaluate the cracked fittings further. Thus, the Aerospace and Maritime Research Laboratory (AMRL) in Melbourne, Australia and the Quality Engineering Test Establishment (QETE) in Gatineau, Quebec, Canada performed failure analyses on the subject components. Additional failure analysis was done by the University of Utah Quality and Integrity Design Laboratory (QIDEC) and IAR (Institute of Aerospace Research) in Ottawa, Ontario, Canada. Figure 5-4 and Figure 5-5 show two views of the pits that nucleated the fatigue cracks. In addition, growth rings typical of fatigue, in this case most likely environmentally assisted fatigue crack propagation, are also clearly apparent. AMRL and QETE were both helpful in identifying the true failure mode in this case. The subject component had not been identified as a structurally significant item. The cracking was found initially by diligent maintenance personnel. Subsequent to the discovery of the corrosion pitting as the source of the cracks a program was put into place to monitor the area in question for corrosion thereby preventing the rampant formation of both corrosion pits and fatigue cracking. This was a significant aid to all the forces flying this particular transport aircraft.

Figure 5-4: Fracture Surface of C130 "Porkchop" Fitting that Unexpectedly Failed from Pitting that Transitioned into Cracks.

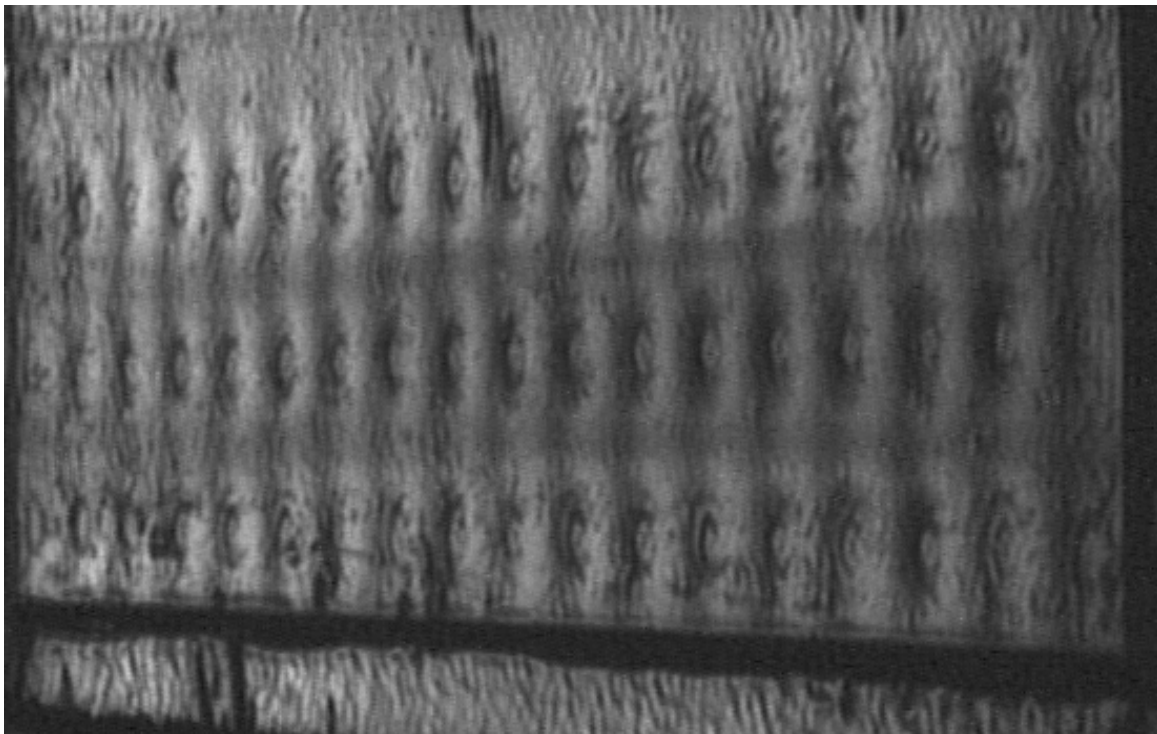
Figure 11-13: DAIS Image of Accelerated Corrosion Pillowing Following 387 Days (9288 Hours) of Salt Fog Exposure.

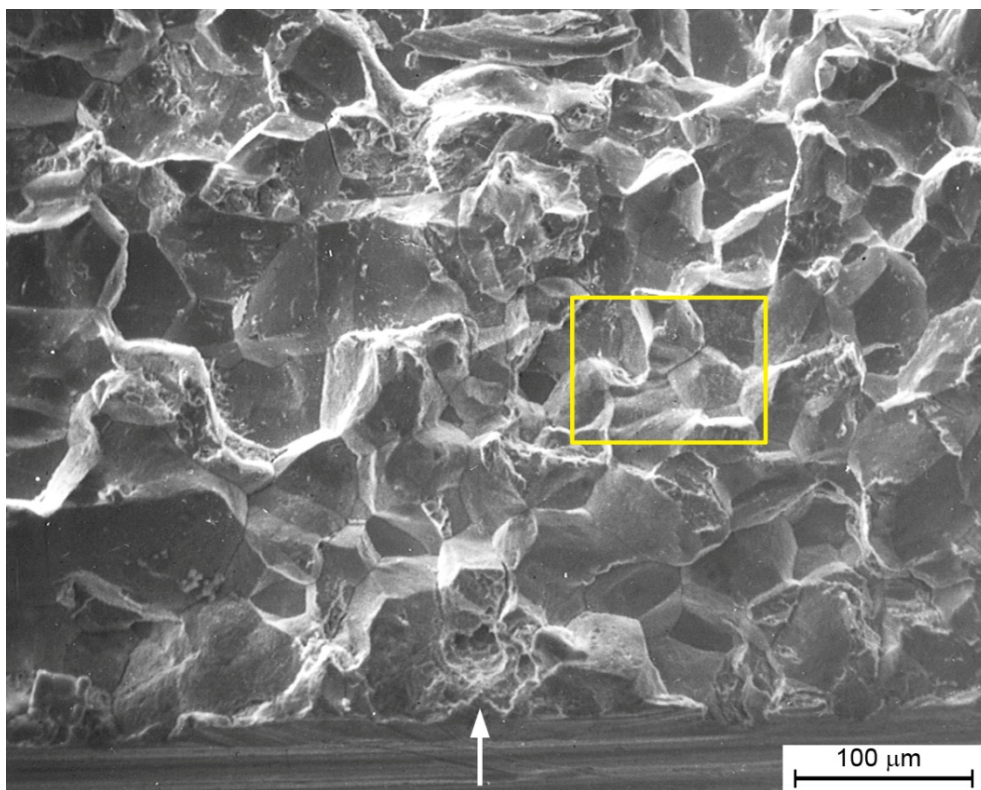
Figure 20-10: Case History 20.5.1 – Overview of Initiation Site O (the arrow points to the pit at the origin – the framed area is shown in more detail in Figure 20-11).

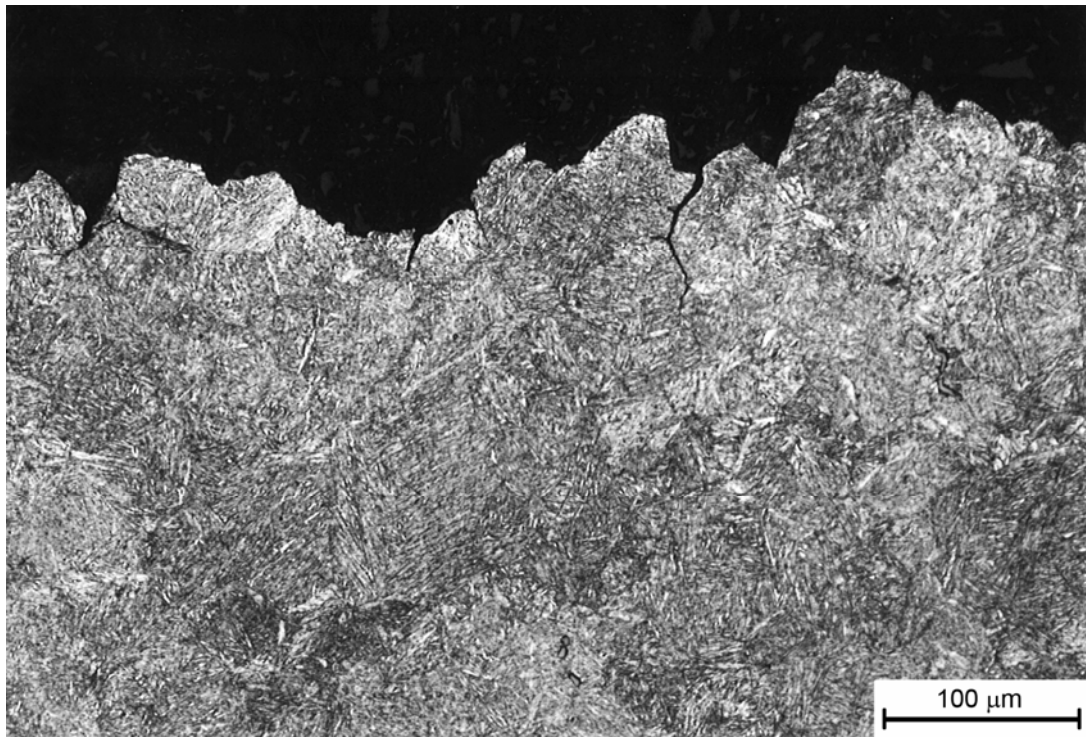
Figure 20-12: Case History 20.5.1 – Nital-Etched Metallographic Section Through Crack A (see Figure 20-8), Showing Tempered Martensite and the Intergranular Crack Path, Including Crack Branching.

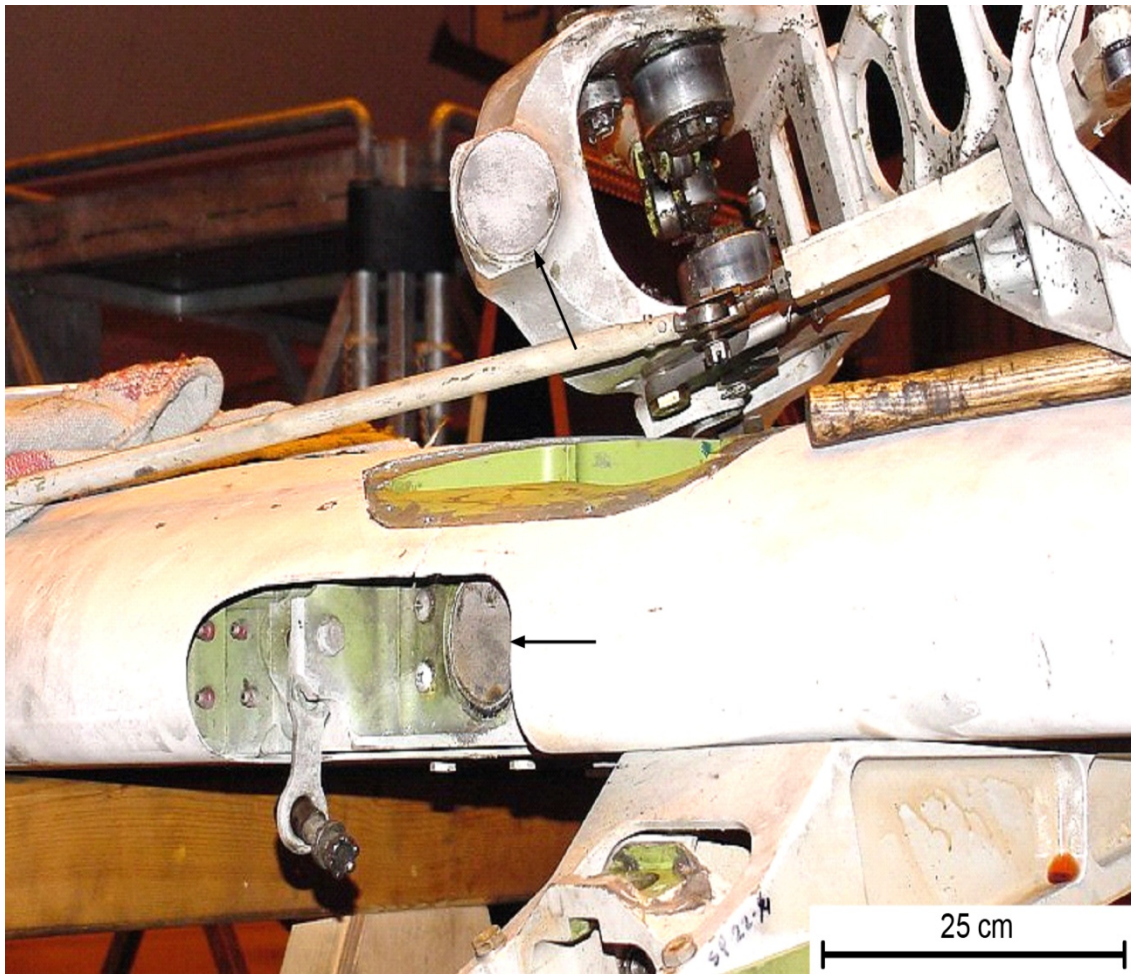
Figure 20-19: Case History 20.5.3 – Broken Inboard Carriage
Assembly *In Situ* (arrows point to the fracture surfaces).

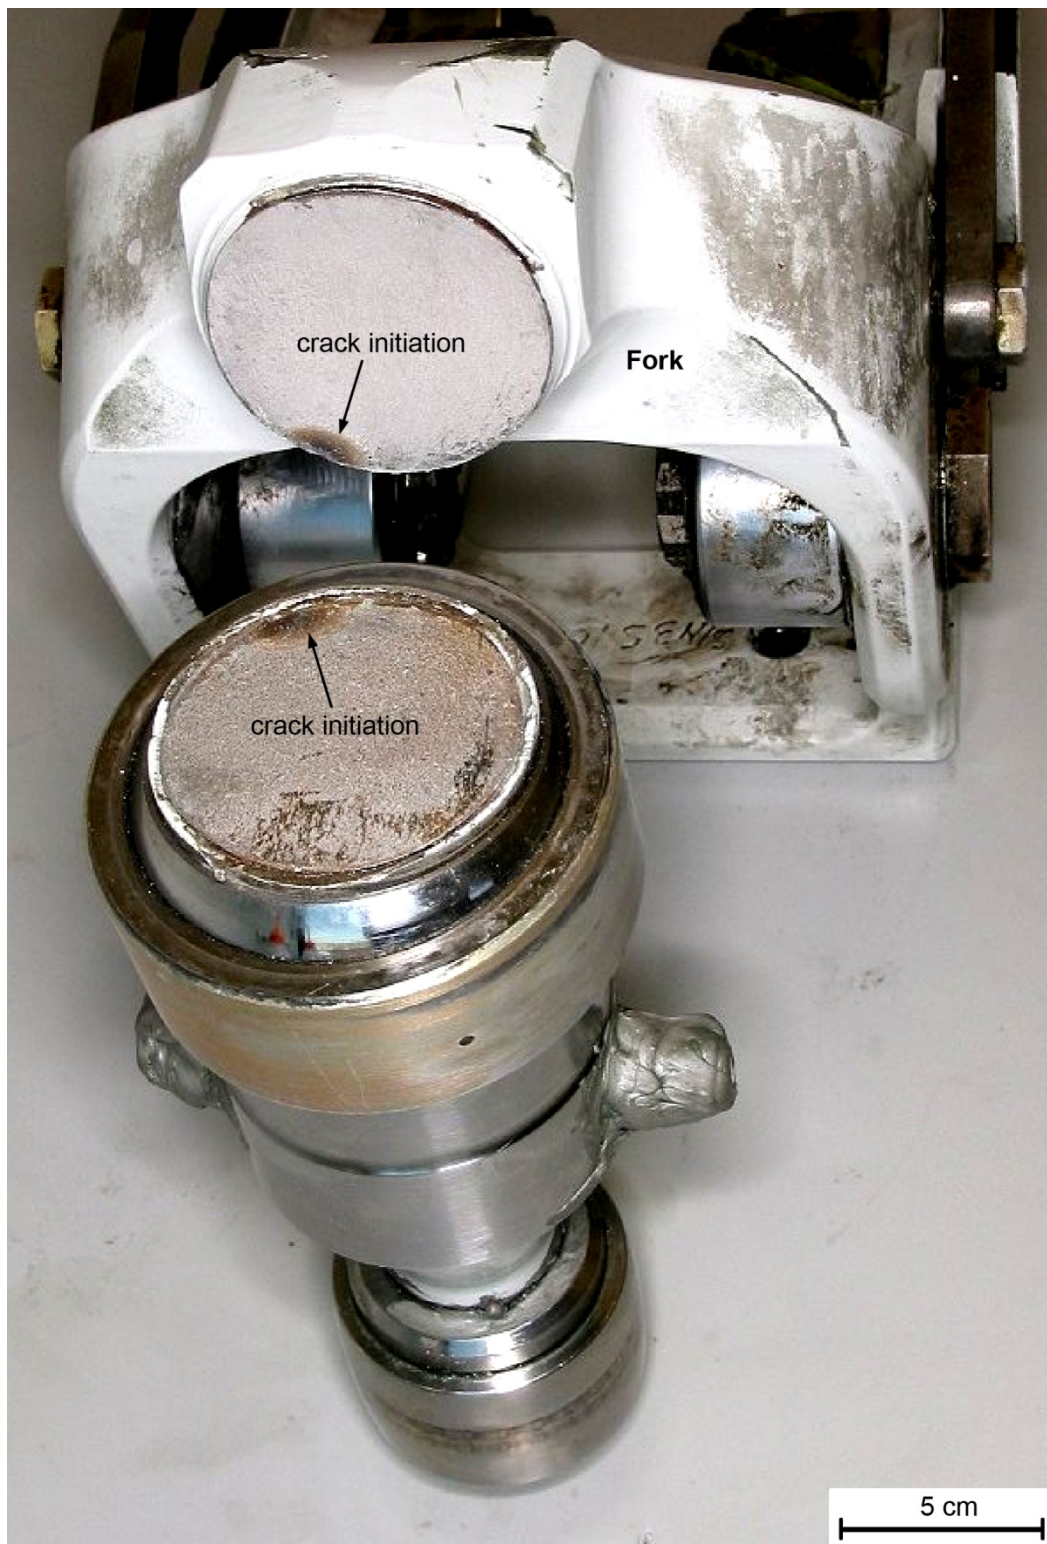
Figure 20-20: Case History 20.5.3 – Overview of the Fractured Spindle and Fork Assembly.

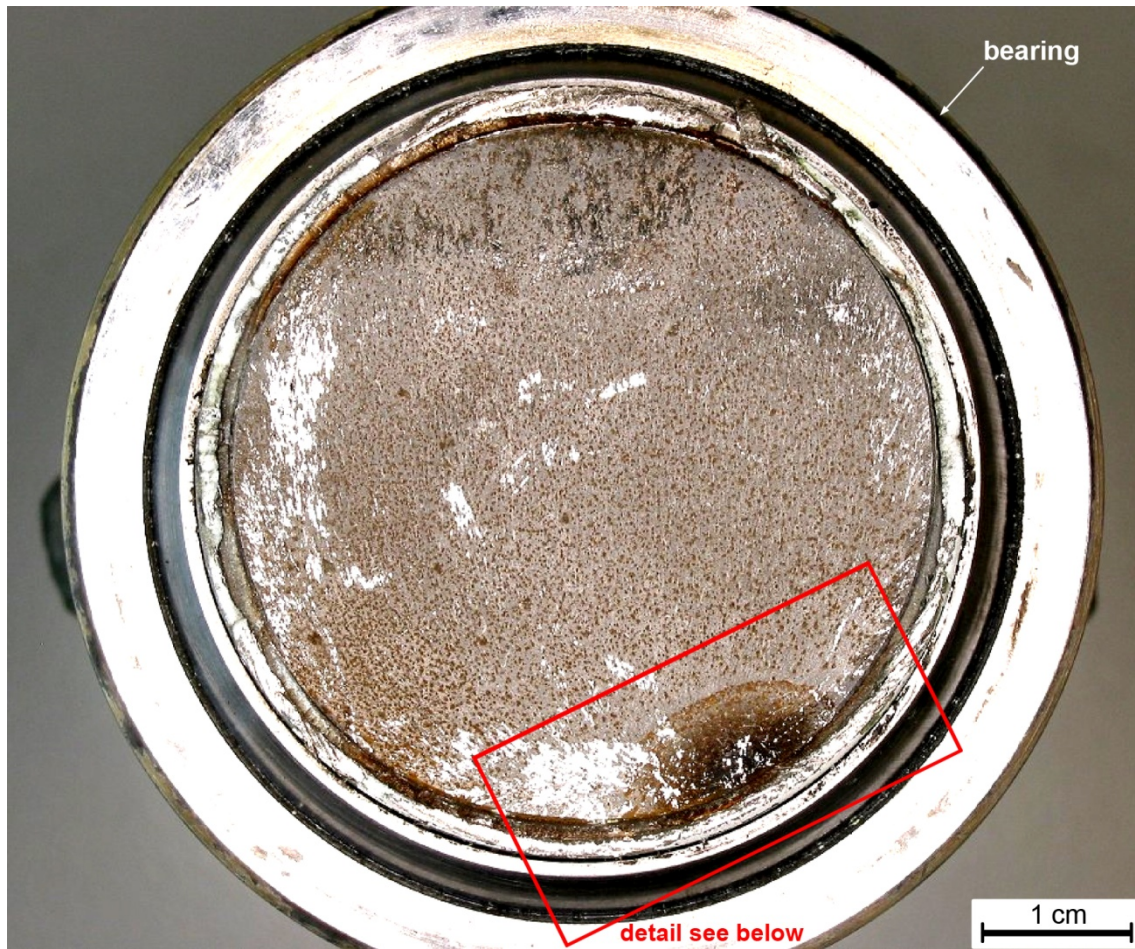
Figure 20-21: Case History 20.5.3 – Spindle-Side Fracture Surface.

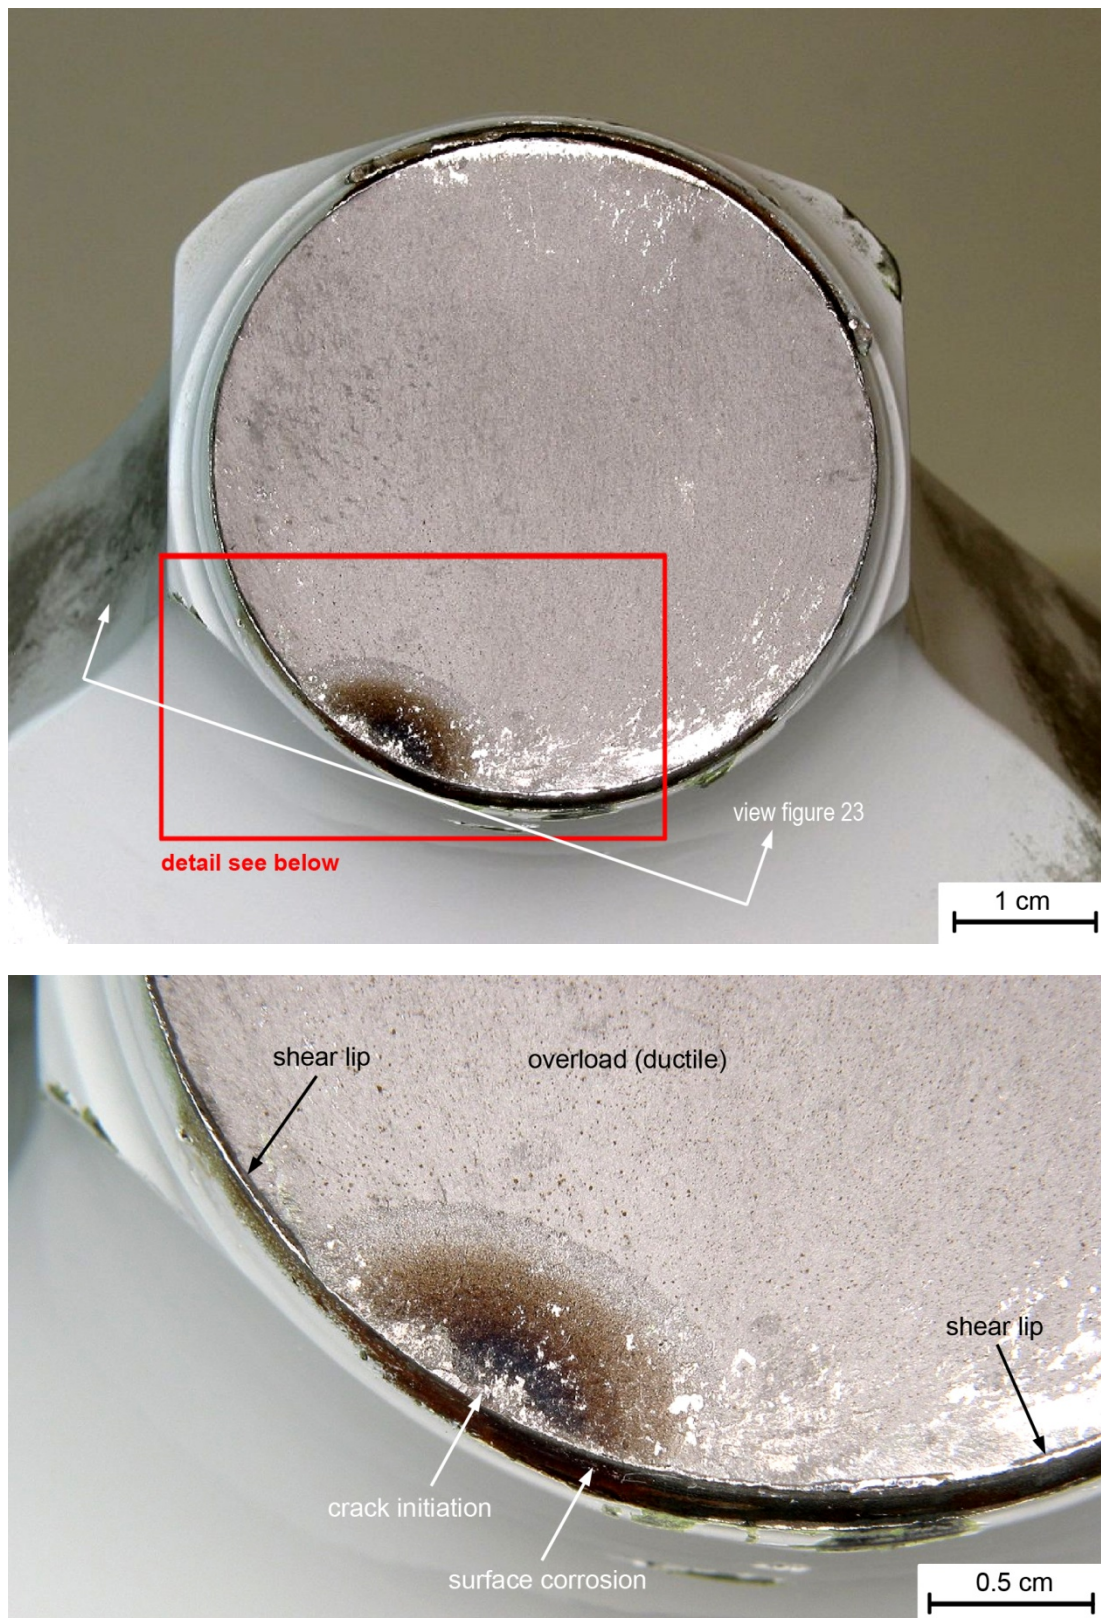
Figure 20-22: Case History 20.5.3 – Fork-Side Fracture Surface.

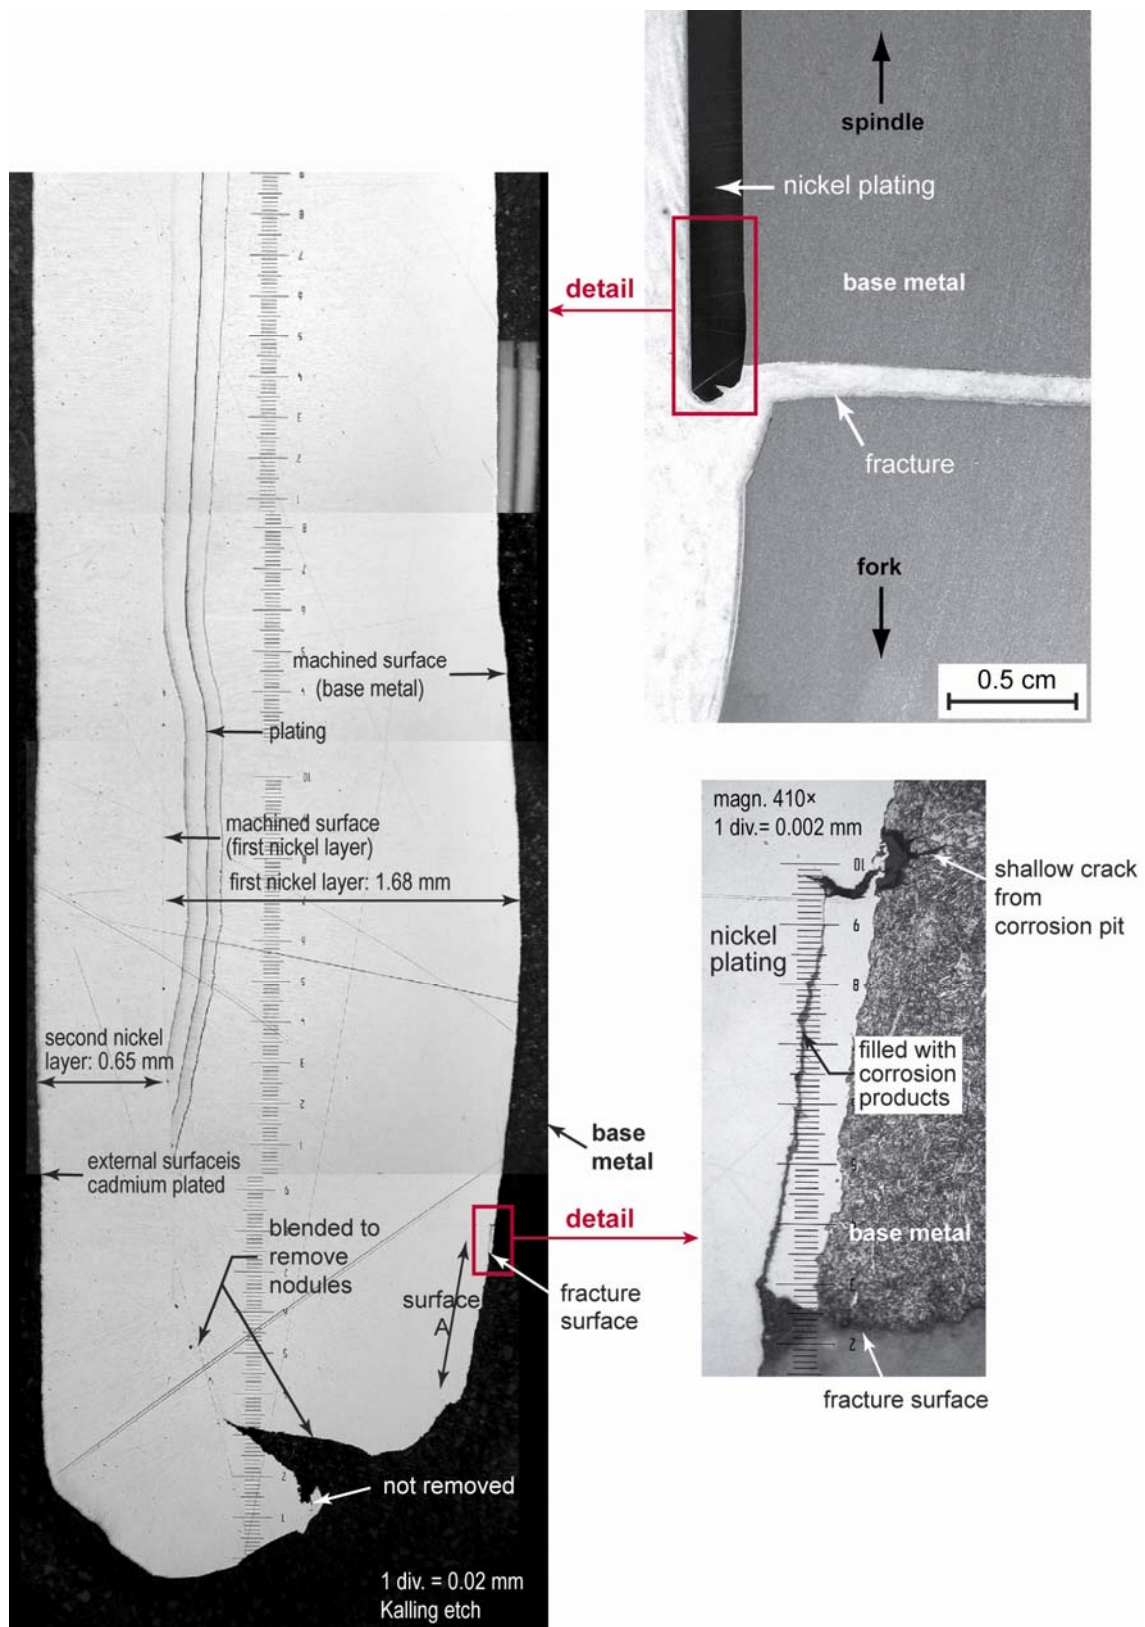
Figure 20-24: Case History 20.5.3 – Metallographic Cross-Section Through the Spindle-Side Crack Initiation Region (Note: Surface A matches surface B in Figure 20-25).

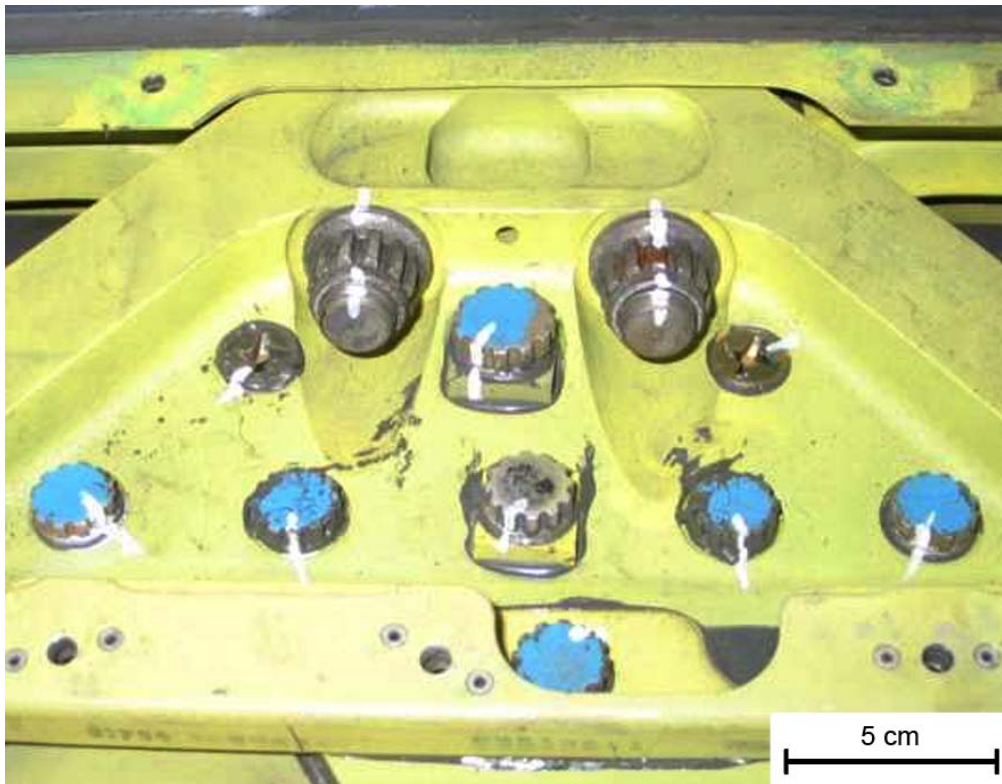
Figure 20-27: Case History 20.5.4 – Example of a Surface-Rusted WAF Bolt (R.H. bolt in photograph).

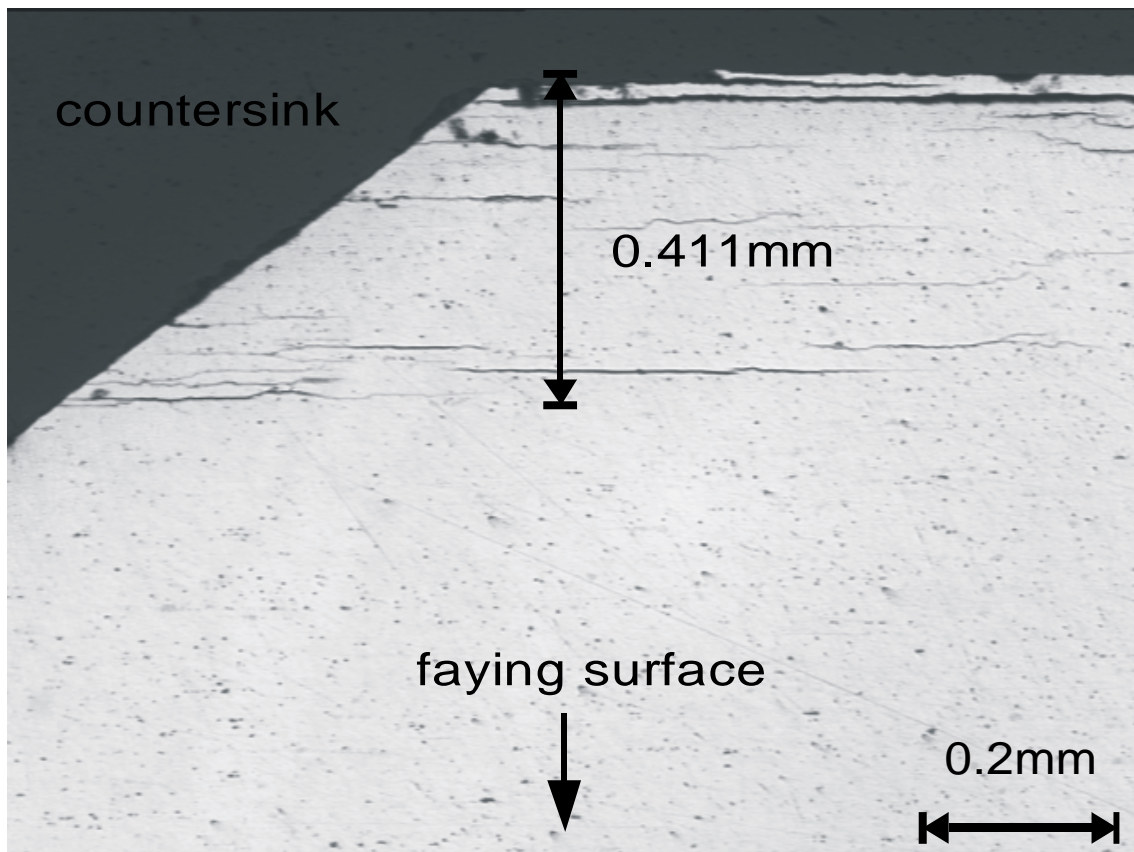
Figure 21-4: Metallographic Section Around a Fastener Hole in a Boeing 707 Wing Skin Plank, Showing Multiple Layers of Intergranular Attack from Pits in the Countersink – the material is 7178-T6 aluminum (from Forsyth et al. [24]).

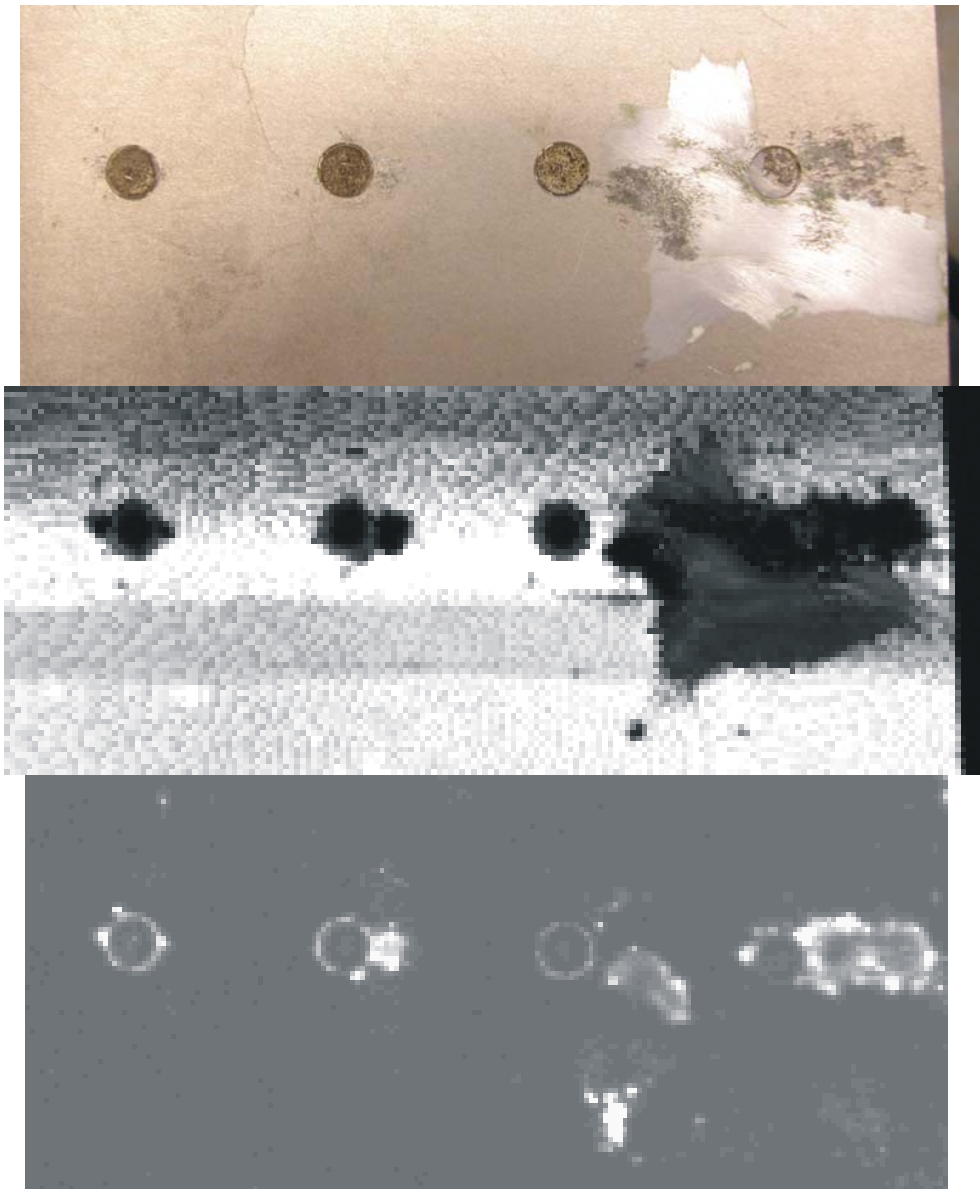
Figure 21-5: From Top to Bottom: A Photograph, a UT Image, and an IR Image of a Section of Wing Plank from a Boeing 707, Showing Exfoliation Damage and Grinding Marks from Repairs – the material is 7178-T6 aluminum (from Forsyth et al. [24]).

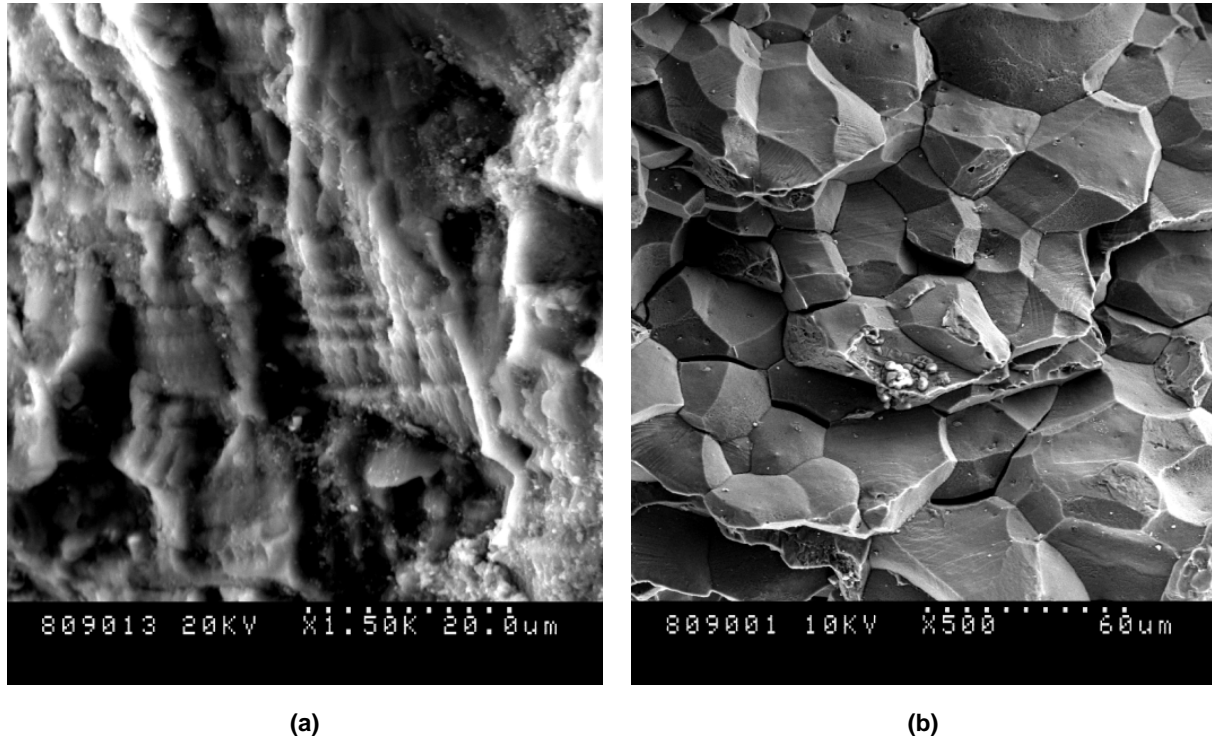
Figure 24-9: Typical Fracture Feature Found During Maintenance Inspection of the CH149 Cormorant at the Secondary Structures (Under-Floor Z-Stiffeners) After Only a Few Years of Service. The most common failure mode observed was (a) small area of fatigue followed by (b) major part of fracture as brittle intergranular failure. The part is made of 8090-T8 aluminum lithium [56].

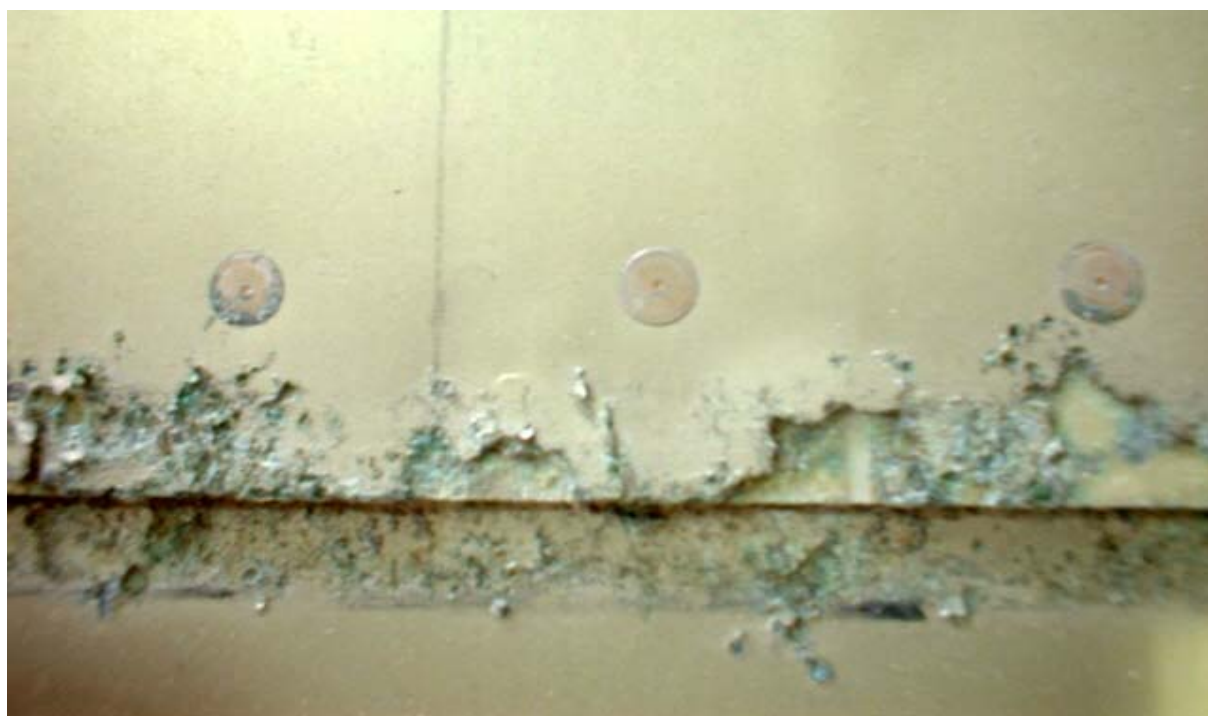
Figure 27-22: Corrosion Damage on Outer Surface of Glare Lap Joint.

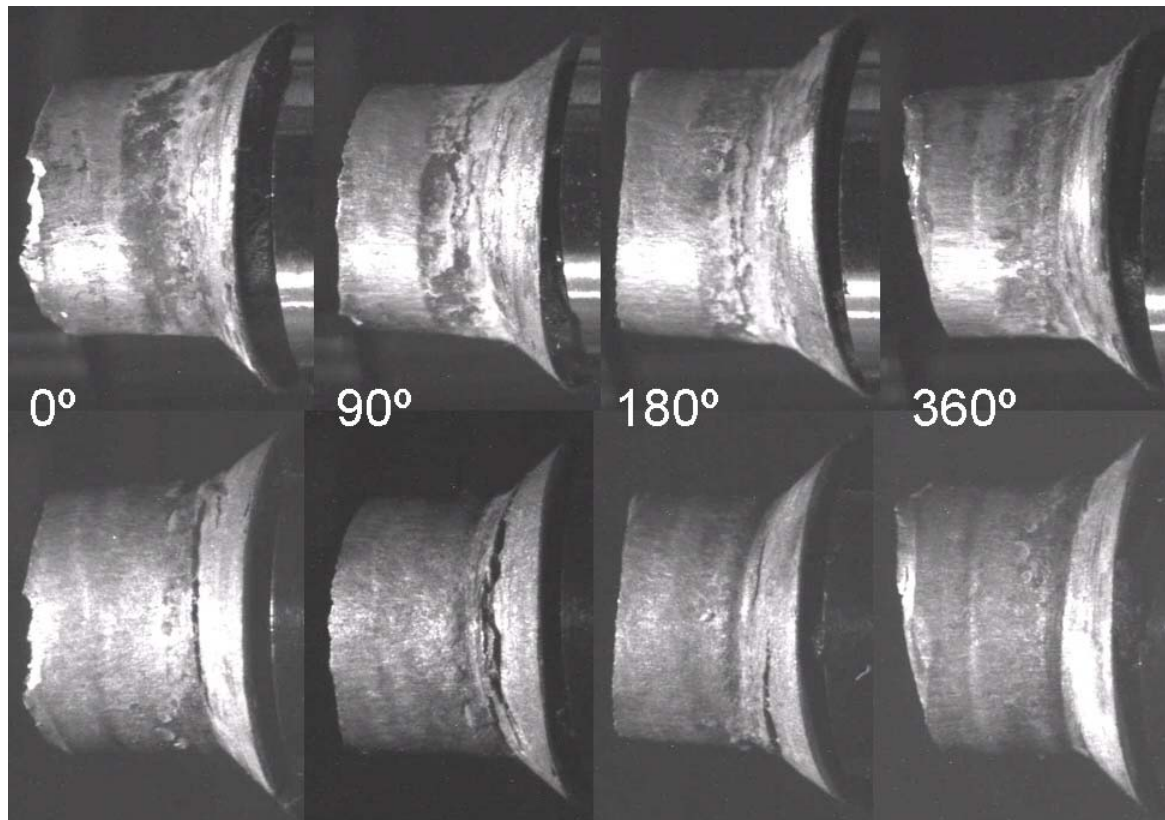
Figure 27-31: Corrosion Pillowing Induced Cracks in a Rivet (Top: As removed; Bottom: Cleaned).
